Study of Bridge Pathologies in the Federal District/Brazil

Lucas Moreira Gomides, Yuri Sotero Bomfim Fraga, Wilber Humberto Vélez Gómez

Abstract– Bridges are important elements for the mobilization of society both in the scope of cargo and people transport and in the connection of roads, seeking to guarantee the continuity of the trajectory. For this, they must have adequate durability and useful life for the purposes for which they are intended. Thus, the objective of this research was to study the pathologies found on a bridge located in Brasilia, Federal District, Brazil. The study was developed through visual inspections and the carbonation test. The results show that the lack of periodic maintenance directly interferes with the reduction of the useful life of the structure, bringing out pathologies and negatively interfering with the bridge's functionality. It was possible to conclude that the bridge under study presents a critical state of conservation of the structure, requiring immediate interventions.

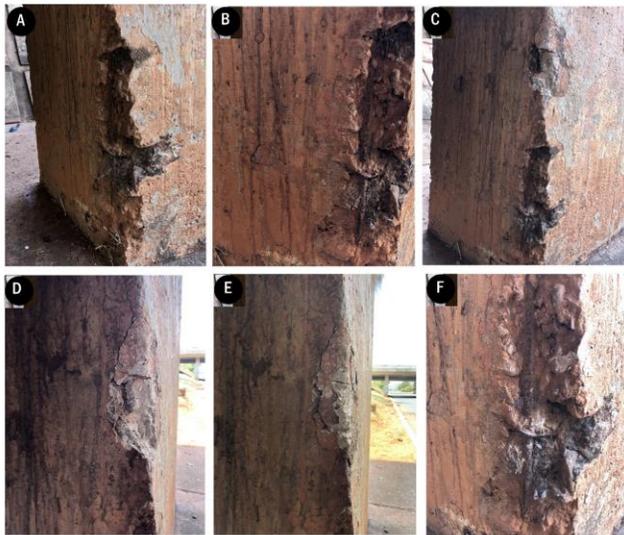
The Fig. 1 illustrates the pillars with a high degree of deterioration, being possible to observe the exposure of reinforcement.

Fig. 1. Reinforcement exposed in different pillars of the bridge

As shown in Fig. 1, the inspection of the bridge pillars revealed the presence of horizontal and vertical cracks, concrete peeling, exposed reinforcement, reinforcement carbonation and corrosion. These pathologies are directly related to the gradual loss of performance of the structure.

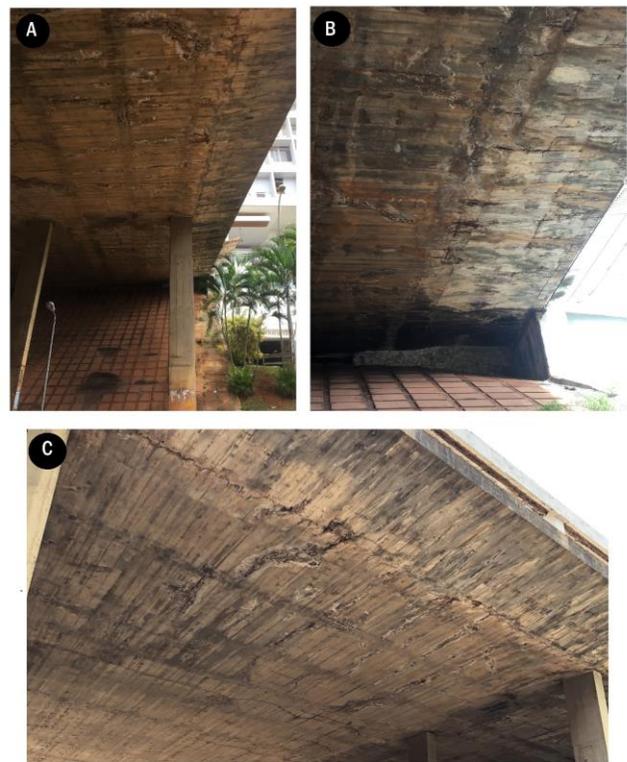
The Fig. 2 shows the lateral edge of the bridge. On the side edge of the bridge, apparent anomalies were also identified. The presence of moisture, cracks, dirt and exposed reinforcement was observed in several points of the structure under analysis. The darker points in the images are characteristic of the presence of moisture with the presence of cracks, where water percolates.

Fig. 2. Lateral edge with the presence of efflorescence, exposed reinforcement, dirt, cracks and cracks

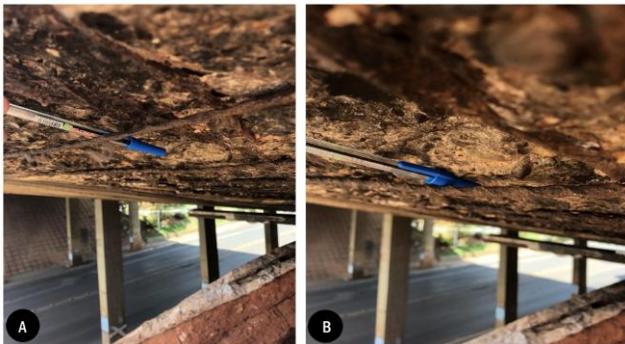
Fig. 5. Exposure and corrosion of reinforcement.

In Fig. 5, it is possible to observe the presence of exposed reinforcement and corrosion of reinforcement. At the point where the problem was found, it is recommended to remove all surface concrete. The reinforcement must be treated by means of a reinforcement brush and application of an anticorrosive primer, so that the upper concrete layer can be redone.

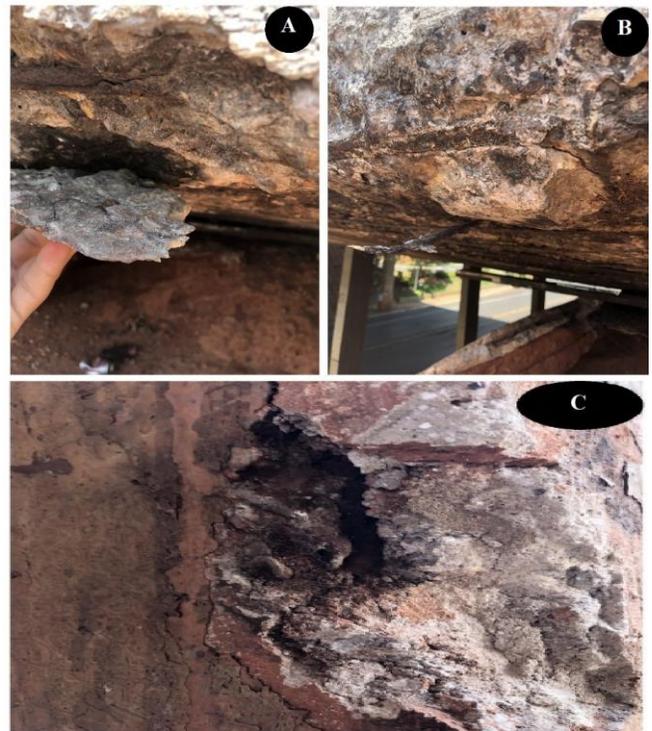
It was noted that some points on the bridge showed fragility in the concrete, as shown in Fig. 6. In order not to cause any major damage to the structure, by using sampling techniques removed with the use of impact equipment, critical points were chosen for the analysis of concrete carbonation, as shown in Fig. 6.

Fig. 6. A) Cracking of the concrete in the tray; B) Fragility in concrete, peeling point; C) Abutment of the concrete in the pillar

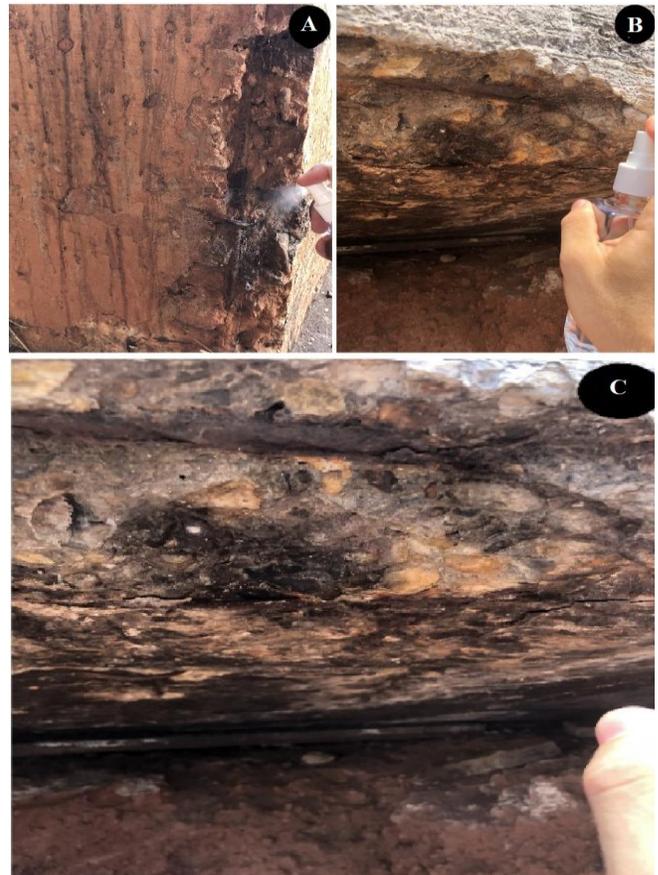
It was observed that several points analyzed are carbonated. This was due to humidity, as the points under analysis have higher rates of rain and infiltration, therefore the pores of the concrete may be more saturated. Fig. 7 shows carbonated areas, in which there was no reaction with the phenolphthalein compound. Thus, there was no change in color, that is, the analyzed points suffered carbonation.

Fig. 7. A) Carbonation test on the pillar; B and C) Carbonation test on the tray
